Report on Inspections of Household Freezers

Prepared for
Gene Hallworth
714-A Trotwood Avenue
P. O. Box 938
Columbia, TN 38402-0938

Prepared by
J. A. M. Boulet
8507 Dresden Drive
Knoxville, TN 37923

Observations

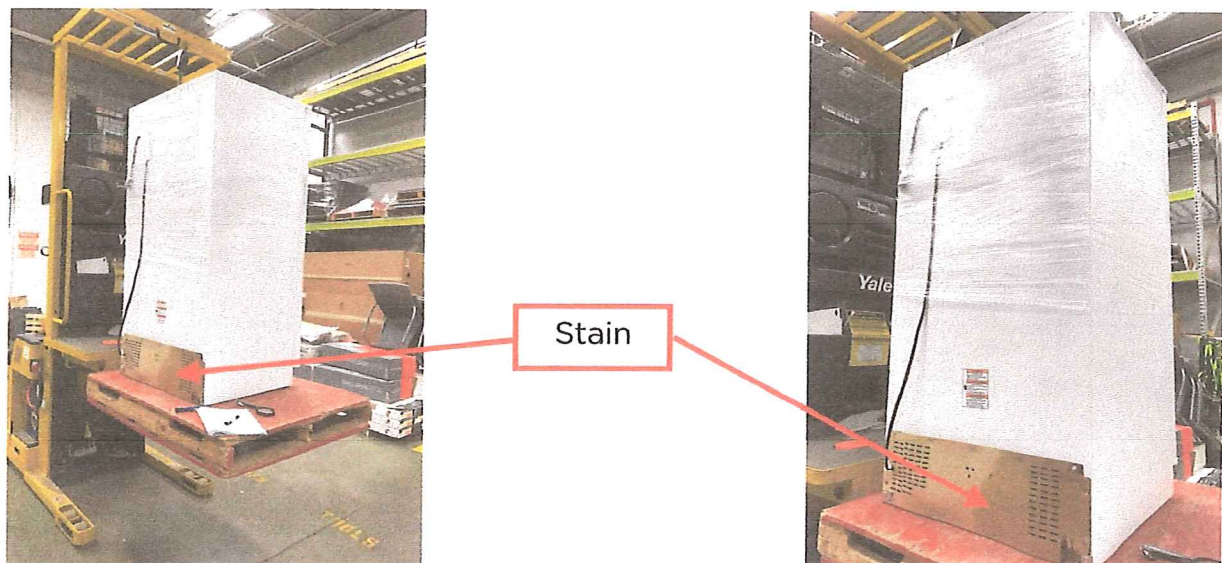
Fig. 5, 6 Freezer at Lowe's, Prior to Inspection

Figures 5 and 6 show the back and side of the freezer prior to inspection.

Note the stain on the fibrous panel, which covers the compartment housing the compressor. Figures 7 and 8 show the front of the freezer prior to inspection and the interior of the freezer, respectively.

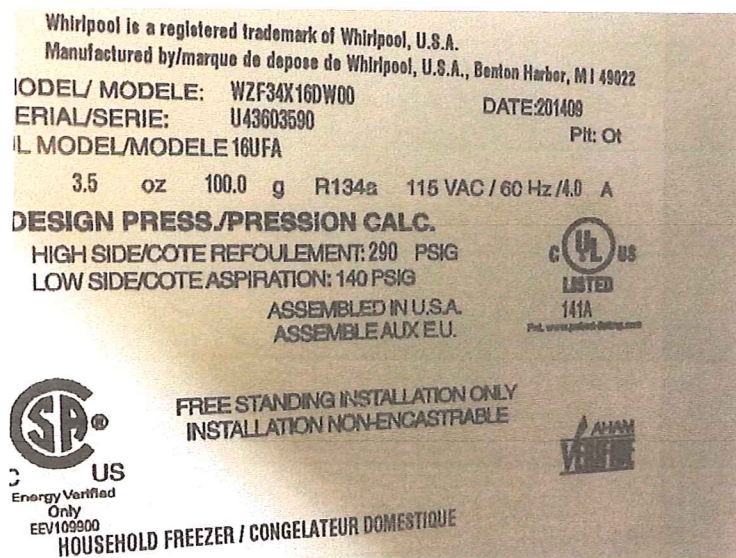
Fig. 9 Information Sticker on Freezer at Lowe's

Figure 9 shows the information sticker for the freezer at Lowe's, showing that the model number matches that of the replacement freezer shown in Figure 3.

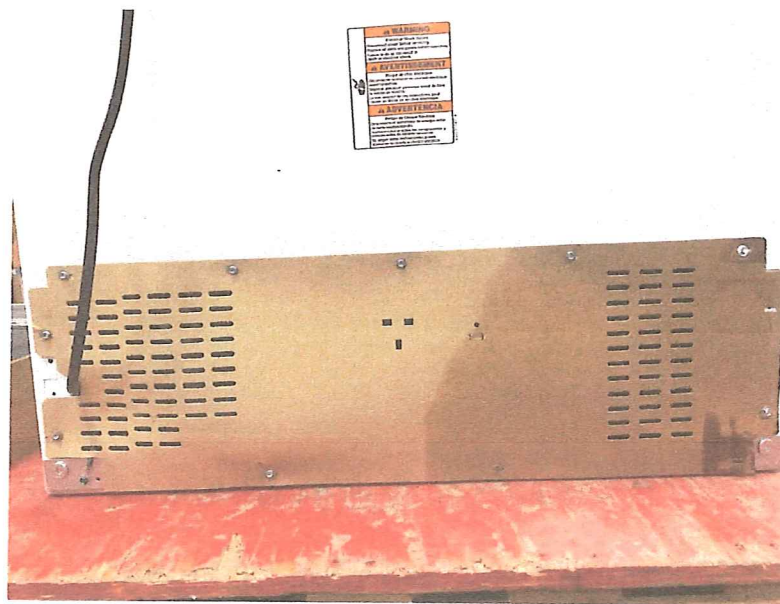
Fig. 10 Panel Covering Compartment Containing Compressor

Figure 10 shows the lower rear of the freezer, giving a clear view of the extent of the stain on the fibrous panel. As will be seen in subsequent figures, the compressor is housed immediately in front of the stained area.

Relative to the stained area on the fibrous panel shown in Figure 10, the soldered joint is approximately centered horizontally.

2. The position of the stain on the fibrous panel covering the compartment holding the compressor is consistent with leaking in the vicinity of the compressor's charge tube.

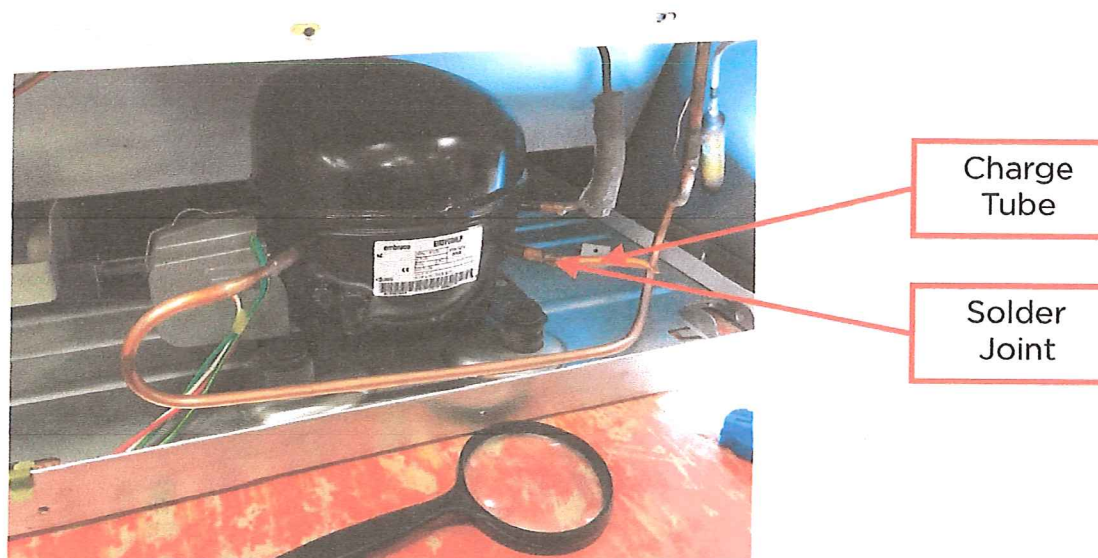
Fig. 11 Compressor Prior to Removal from Freezer

Figure 11 shows the compressor after removal of the fibrous panel. The location of the compressor is immediately in front of the stained area on the fibrous panel that covered the compartment. Note the position of the charge tube. The leak probably originated at a crack in the noted solder joint in the charge tube.

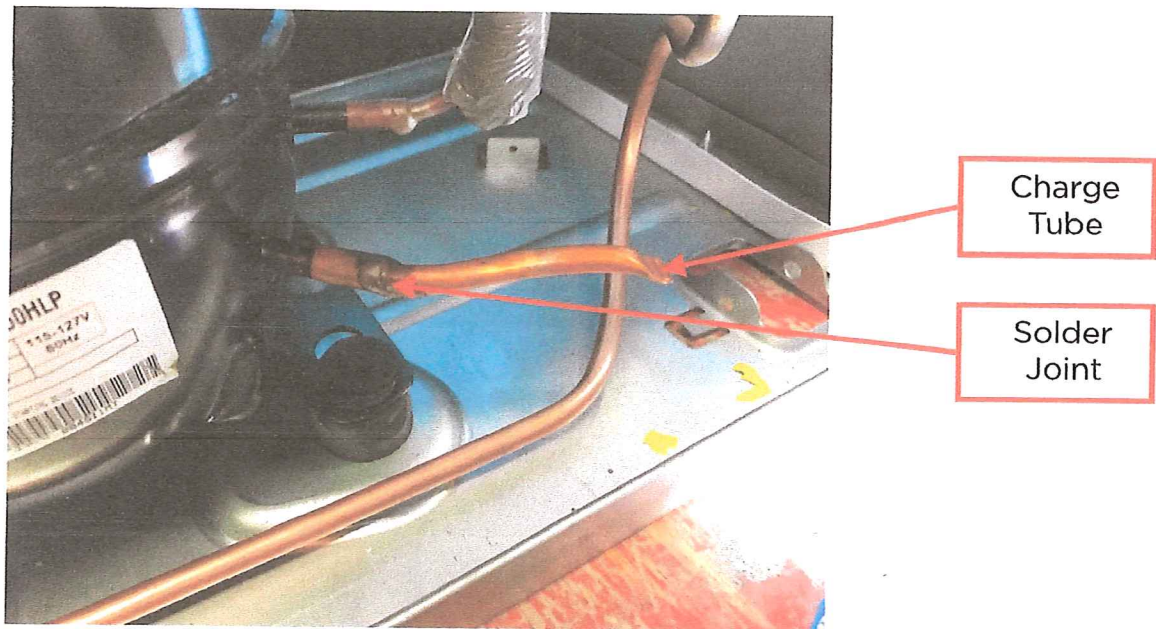
Figure 12 is a closer view of the charge tube region shown in Figure 11.

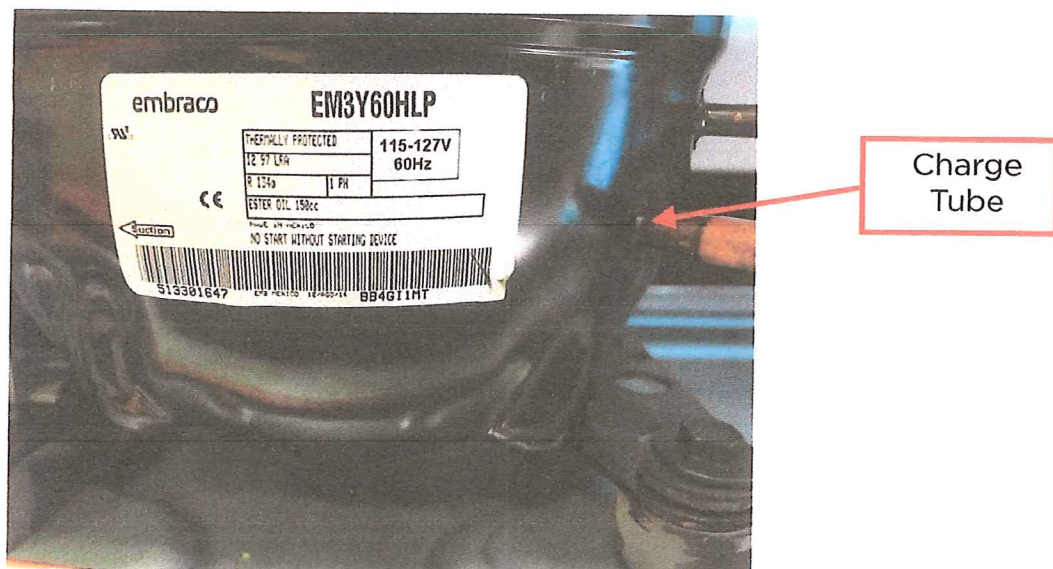
Fig. 13 Compressor's Information Sticker

Figure 13 shows the information sticker on the side of the compressor. The point where the charge tube enters the compressor's housing is noted.

4. Absence of refrigerant in the compressor did not cause the motor to run continuously until it was damaged.
5. Less than 75 milliliters of oil (45 ml at Lowe's, less than 30 ml at the machine shop) was recovered from the compressor. Hence, the total volume of oil remaining in the compressor was less than half of the total oil in the system as indicated by the compressor's information sticker in Figures 13 and 20 (150 cc = 150 milliliters).

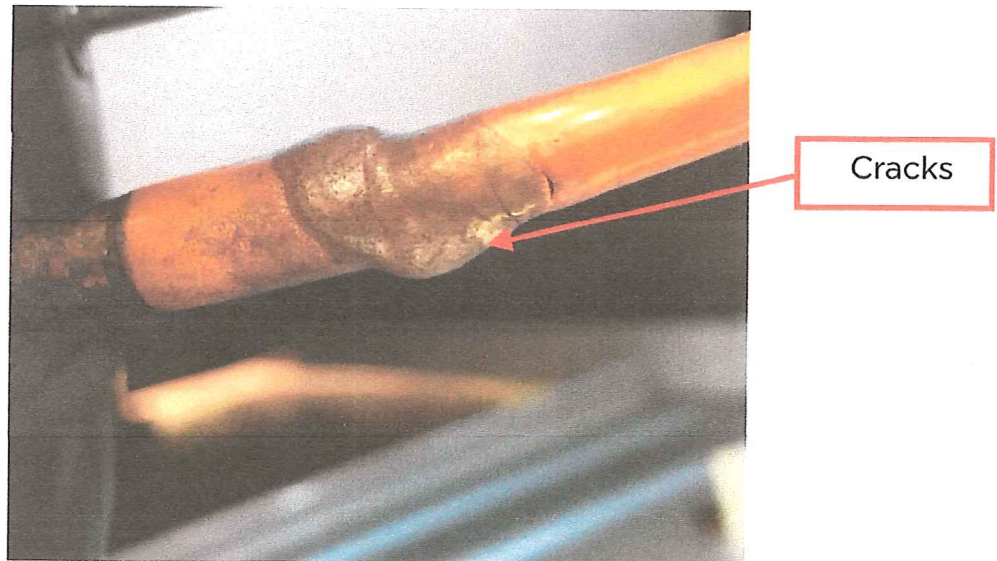
Fig. 14 Cracks in Solder Joint

Figure 14 shows cracks in the solder joint, through which the refrigerant probably leaked into the room where the freezer was initially installed.

1. Cracks in the solder joint of the charge tube, such as those seen in Figure 14, would have allowed a mixture of oil and refrigerant (R-134a) to leak from the compressor into the room where the freezer was initially installed.

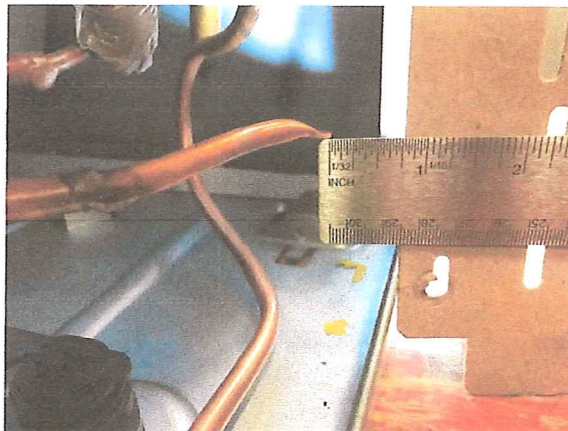
Fig. 15 Distance between Charge Tube's End and Fibrous Panel

Figure 15 shows a measurement indicating that when the fibrous panel was in place, the distance between the panel and the crimped end of the charge tube was about 3/4 inch. Measurement of the deflection of the fibrous panel due to pushing in by hand near the crimped end of the charge tube indicated that contact between the panel and the charge tube was highly unlikely. This implies that the cracks in the solder joint of the charge tube were most likely not caused by bending of the tube due to contact with the panel after the panel was installed.

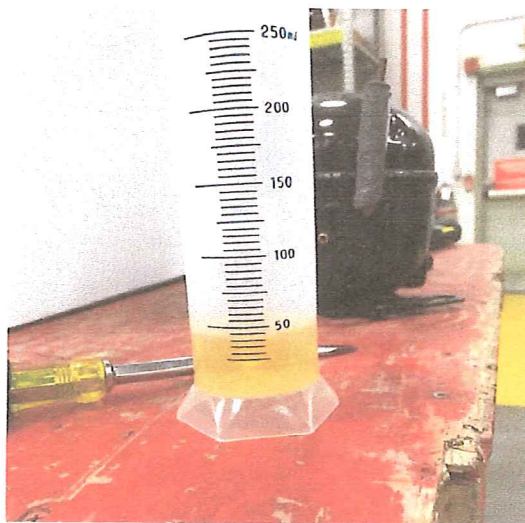
Fig. 18 Oil from Compressor

Figure 18 shows that the volume of oil poured from the compressor was approximately 45 milliliters.
